AIR LEAKAGE TEST REPORT EPA REGION 8 HEADQUARTERS, DENVER, CO

Fred Bauman, Tom Webster, and Darryl Dickerhoff

Center for the Built Environment (CBE)
University of California, Berkeley

August 2008

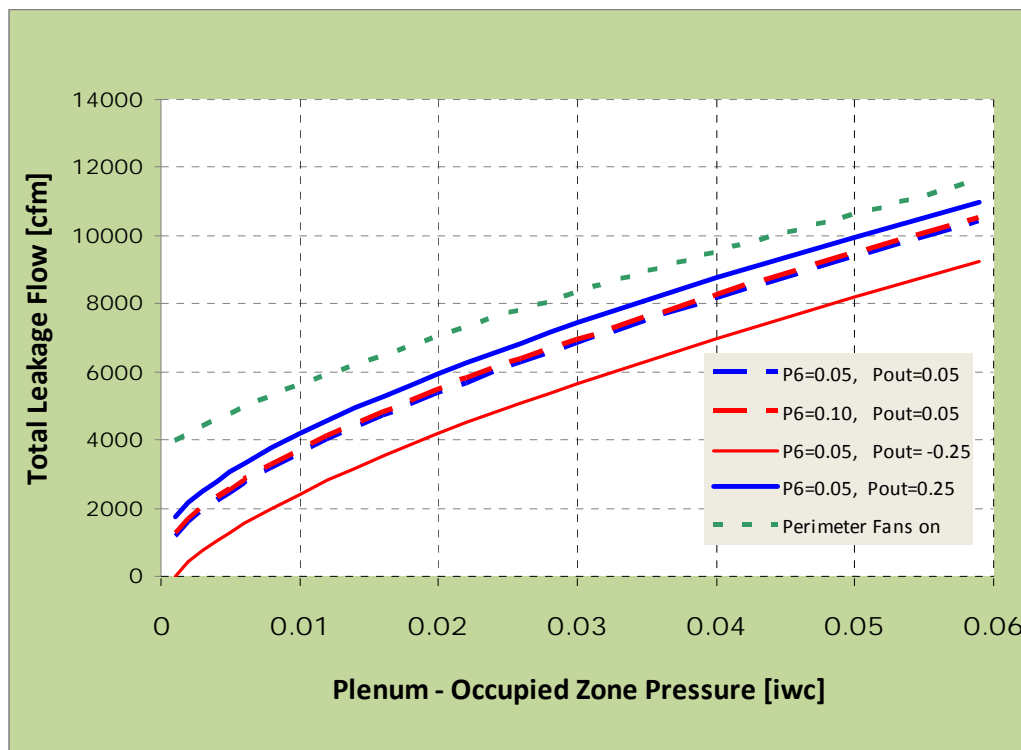
Figure 5: Leakage flow rates for selected pressure differences per leak path where P6 = pressure difference to 6th floor, and Pout = pressure difference to outside

Figure 5 is a chart that shows the regression curves that resulted from the multi-path analysis. The various curves show total measured leakage as a function of plenum/room pressure difference for different combinations of pressure differences along the other two air leakage pathways: to the 6th floor and to the outside. These results demonstrate that you can obtain a different measurement result for total leakage depending on the pressure differences that exist along all leakage pathways at the time of the measurement, not the plenum/room pressure difference alone.

EPA Test Results: Table 4 summarizes the test results for Test 3 for each of the four contributing air leakage pathways for the 7th-floor plenum at a pressure of 0.05 iwc. Note that as these measurements were made with the same "sealed diffuser" configuration as the first test, the sum of these four leakage components equals the total airflow of 9380 cfm obtained in the "sealed diffuser" Test 2 (@ 0.05 iwc). Several significant observations can be made:

- Leakage to the 6th floor and to the outside (equal to Category 1 leakage) is extremely small at 442 cfm and is just over 1% of the design airflow rate of 1.43 cfm/ft² (see Table 1).

- Nearly half of the total leakage is through cracks along the edges of the window sill. This leakage was created when we taped over the perimeter linear grilles, thereby diverting the air out through the unsealed cracks on both edges of the window sills. Since the intent of taping over the grilles was to prevent any airflow from entering the room, this leakage can be considered as a “false leakage” resulting from our inability to seal the perimeter diffusers completely. In normal operation the pressure at this leak site is determined by the operation of the perimeter fans and is not well coupled to the underfloor plenum pressure and in fact may be minimal compared to the opening of the perimeter diffuser itself. As discussed further below, it should be subtracted from the measured leakage to obtain the true Category 2 leakage to the room.

- Leakage to the room (except for the perimeter crack leakage described above) represents the true Category 2 leakage and was measured to be 0.16 cfm/ft², or 11.2% of the design airflow of 1.43 cfm/ft², as listed in Table 1.

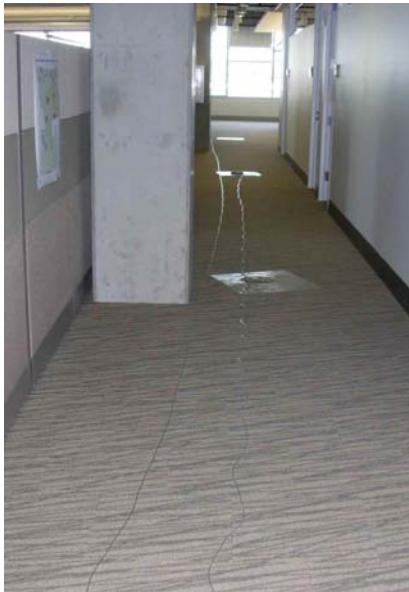
Figure 6: Installation of tubing for plenum pressure measurement

4. Install pressure sensing tubing from command center to eight underfloor plenum pressure measurement locations on the 7th floor to allow multi-point monitoring of plenum pressure distribution during subsequent air leakage tests (see Figure 6 and Figure 7. These eight locations were selected to match the eight installed plenum pressure sensors shown in Figure 2. Also run tubing to the 6th floor (all floor were open (i.e., no return plenum) with "cloud" acoustical ceilings) and to the outside to allow monitoring of pressures in adjacent spaces to 7th floor underfloor plenum.

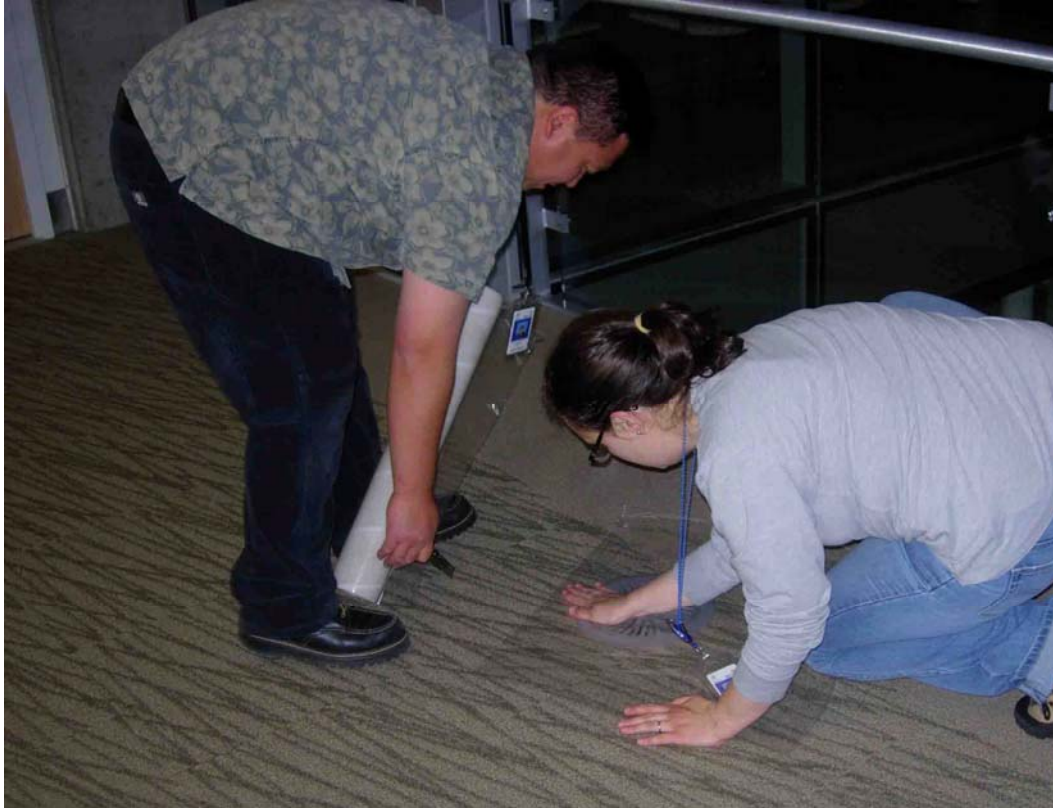
Figure 8: Applying wide “carpet mask” tape over swirl diffuser

5. Seal all floor diffusers (swirl) and perimeter linear grilles (located on window sills) using specially sized wide tape ("carpet mask" and "duct mask"). See Figure 8. Some floor cable (PVD) outlets were also sealed, although the building had very few since electrified modular furniture was used throughout the largely open plan office.

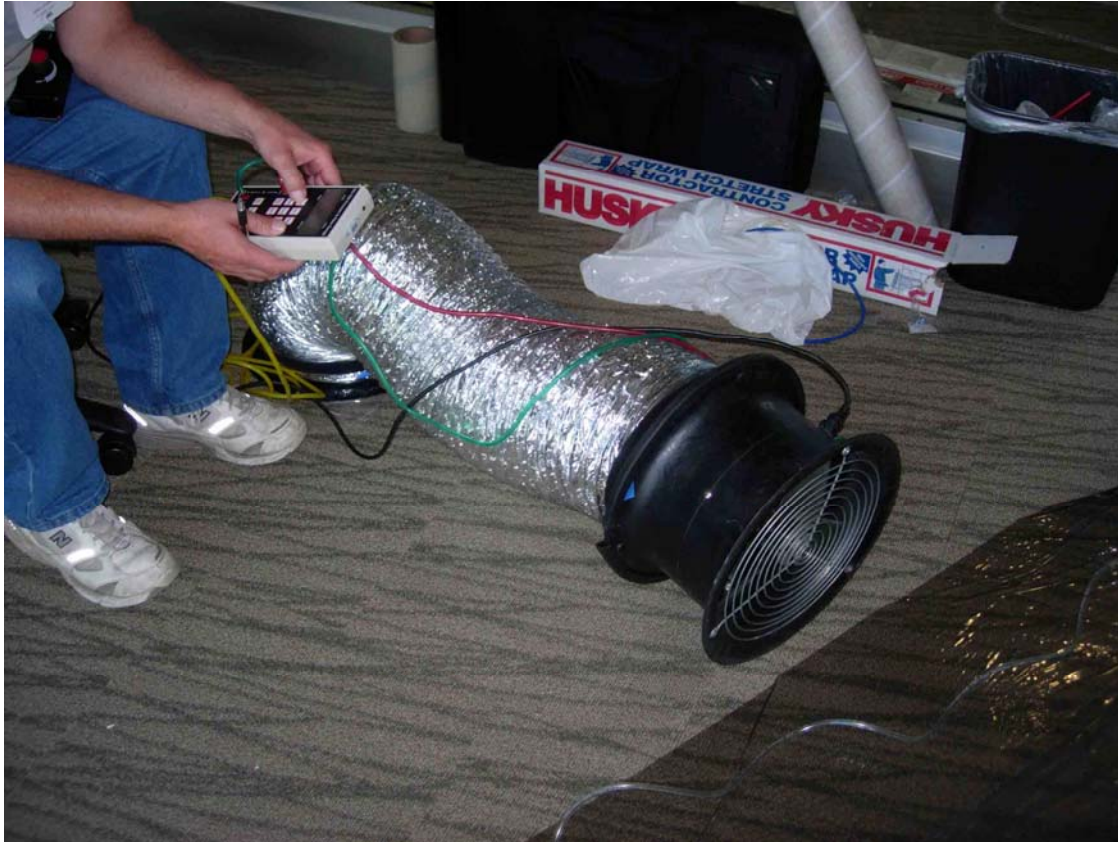
Figure 9: Duct Blaster shown being used as a powered flow hood to measure flow through swirl floor diffuser

3. Conduct airflow measurements of 2-3 swirl floor diffusers. These tests were intended to characterize the airflow through the diffuser for two manually adjusted damper positions: (1) fully open and (2) fully closed. A powered flow hood was used to measure these small flows. A powered flow hood uses a calibrated fan, in this case a Duct Blaster, to measure the flow and to overcome the flow resistance of the relatively small flow sensor necessary for accurate determination of low flows. Flows as small as 10 cfm can accurately be made using a Duct Blaster (see section 13.3 of the Duct Blaster manual).

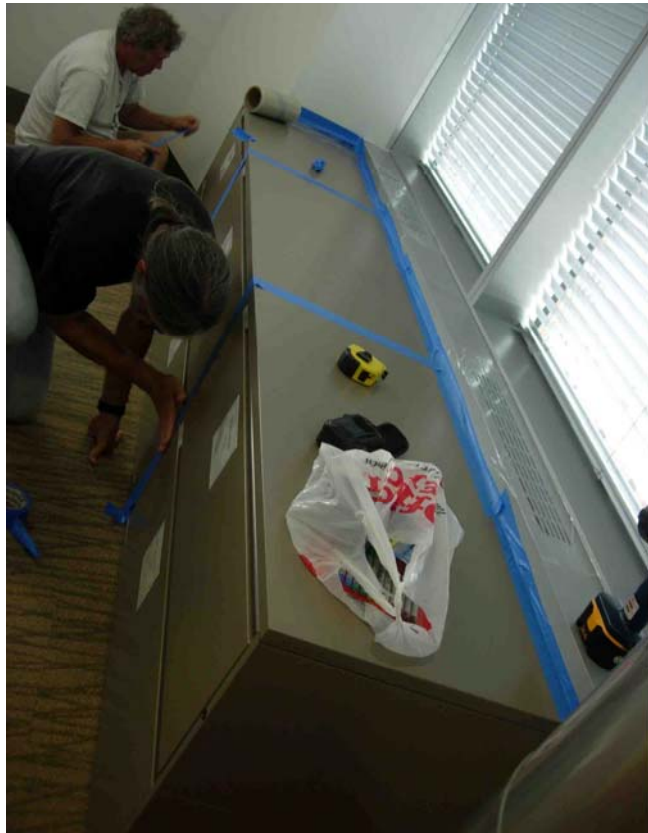
Figure 14: Taping cracks and cabinets at perimeter

significant airflow was still able to leak into the room through these gaps or cracks along the edges of the sill plate. In our testing we discovered this extra leakage and were able to account for it in our analysis. Our testing method included additional measurements when we completely taped and sealed all cracks along the window sills of three of the 21 perimeter fan units. Since this extra leakage was created only when we unsuccessfully taped the perimeter grilles shut during the sealed diffuser test, we recommend that it be subtracted from the total leakage measurement to obtain the true leakage from the plenum.

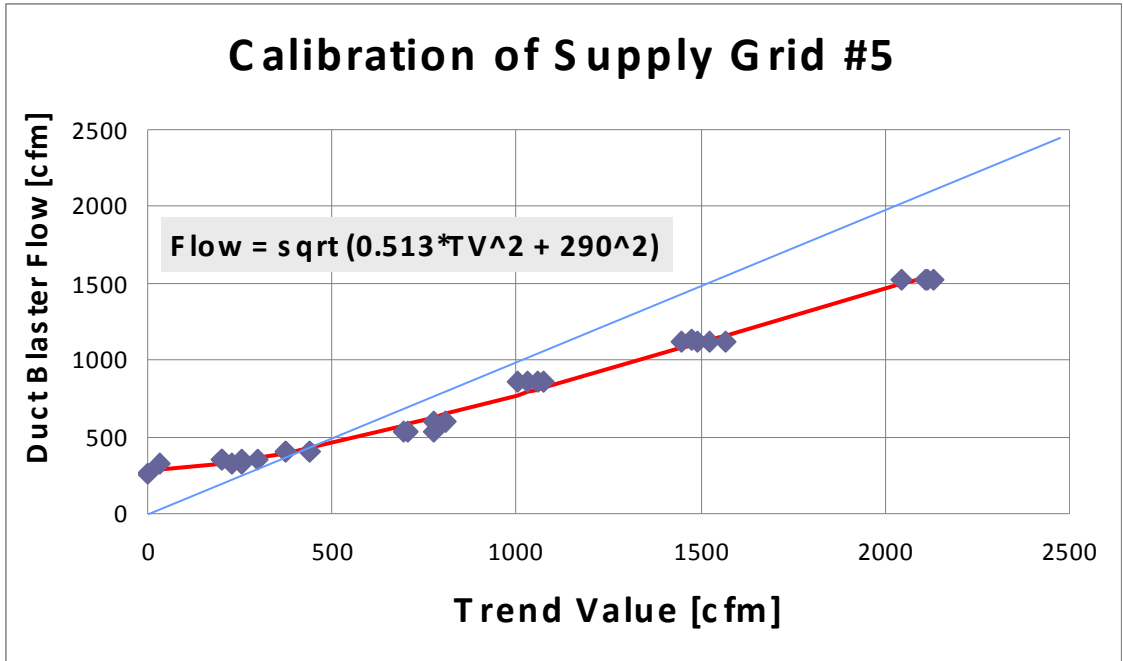
Figure B1: Example calibration data for flow station 5.

Figure B1 shows the calibration data for flow grid #5, and Table B1 has the values determined for each flow grid.
